International Congress of Science and Technology of Metallurgy and Materials, SAM –
CONAMET 2014

19th century wooden ship sheathing. A case of study: the materials of Puerto Pirámides 1, Península Valdés

Horacio M. De Rosa ^{a,b,*}, Nicolás C. Ciarlo ^{a,c}, Marcela Pichipil ^{a,b}, Ana Castelli ^{a,d*}

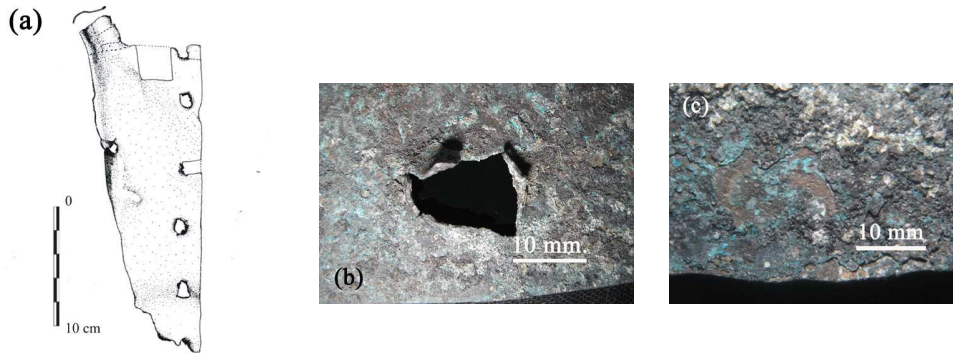
Fig. 1(a) illustrates the sheet, where four aligned holes can be observed, through which fastening tacks passed.

The average diameter of the holes is 12 ± 2 mm and they are 55 ± 5 mm distant from each other. In Fig. 1(b) one of them can be seen in detail. Both sides of the sheet are covered in dark corrosion products (blackish and green-turquoise coloration), of granular morphology, that in some areas flake off (Fig. 1c). The thickness of the sheet, including the products, is of between 0,9 and 1,2 mm.

Heavily corroded copper based alloys on maritime environments present a greenish patina on their surface, with a predominant presence of atacamite, similar to that present in the sheet under study. Schweitzer (2007). Furthermore, in some areas, SEM revealed corrosion products with the shape of faceted crystals (Fig. 2). The morphology of the crystals is similar to that studied by Stoffyn-Egli and collaborators in brasses exposed to maritime environments. Furthermore, these authors noted a crystal-looking Cu-Zn hydrated sulfate. Stoffyn-Egli (1998). The composition of the sample, previously pickled, analysed by the techniques quoted above, is of 60,8% Cu and 37,6% Zn, with small percentages of other elements, namely: 1,3% Pb; 0,7 % Sn; 0,6% Fe and 0,015% S (in weight). Two areas of the sheet, one pickled and unpickled the other, were analysed by EDS. In table 1, the average compositions obtained are shown, and in Fig. 3, the representative spectrums. According to the mentioned results, the sheet is made of a Cu-Zn alloy, with traces of Fe and S. This composition is similar to a 60/40 brass known as Muntz metal, for which George

Figure 1 – Piece of Hull sheathing from the site PP1: a) illustration of the studied fragment; b) fastening hole; c) surface of the piece.

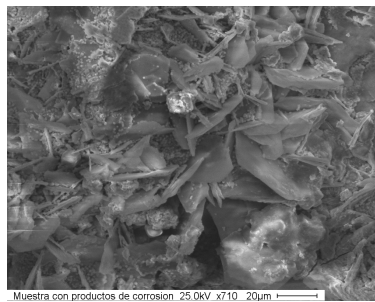
Figure 2 – SEM image of the faceted corrosion products.

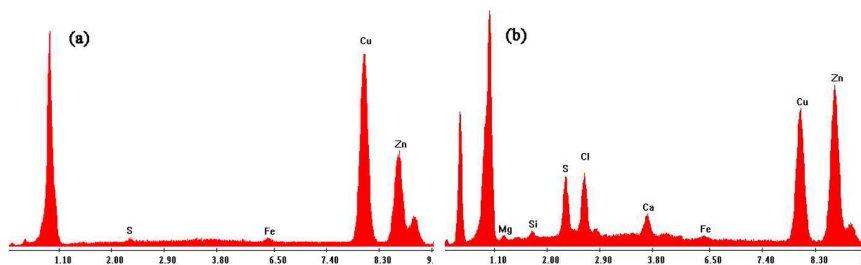
Figure 3 – EDS spectra, representative of the following areas: a) pickled(using oxalic acid); b)unpickled.

The unpickled sample presented higher quantities of Zn, less Cu and similar amounts of Fe than the pickled one.

Furthermore, a rise in S proportion could also be detected, as well as the presence of Si, Cl, Ca and Mg, elements associated to corrosion processes.

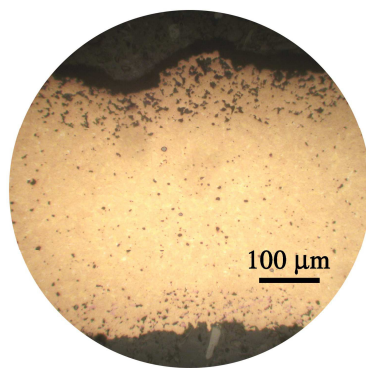
A sample for microstructural analysis was extracted from the sheet. It was pickled and mounted in Bakelite. The thickness, measured in this specimen, is of 0.41 ± 0.07 mm. The surface of the sheet is corroded, and exhibits slight traces of dezincification, perceptible because of their reddish color (Fig. 4). Towards the centre, on the other hand, evenly distributed micropores can be observed.

Figure 4 – Sheet section (polished, with no chemical etching) presenting evidence of degradation on the sheet's edge

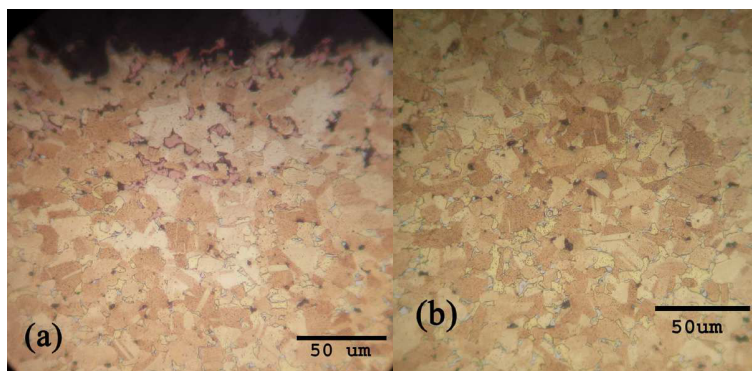
The microstructure and chemical composition mentioned correspond to an alpha-beta ($\alpha+\beta$) brass of small equiaxed grains, with no plastic deformation (Fig. 5), with low β phase proportion (dark areas). The α phase grains present straight lines of annealing twins, that are typical of this kind of material. This microstructure is similar to the one registered in sheathing sheets found in other sites from the 19th century. Lorusso (2003). Furthermore, white areas and semispherical grey particles can be observed, mainly located at the grain boundaries of α phase and associated to β phase (Fig. 5b.)

Figure 5 – Photomicrography of a section of the sheet: a) edge of the sample; b) center. Etchant: HCl FeCl₃ aqueous solution

Corrosion by dezincification, illustrated in Fig. 5, is typical of brasses exposed to salty environments (i.e. maritime) and its intensity varies according to the alloy composition and the β phase content. Davies (1993); Polan, (1992). Generally, a presence of Sn in percentages above 0,5% enhances the resistance to corrosion by dezincification. Polan (1992); Campanella et al. (2009). In this case, the presence of Sn can be considered either to have been caused by contamination during the manufacturing process or to have been added deliberately, foreseeing the sheet's function.

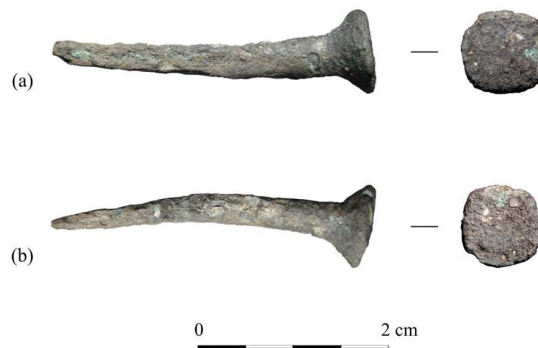
Fig. 6 illustrates the studied tacks. These have a square head $9 \pm 0,3$ mm wide at the edge. In Table 3, their code, measures and general characteristics are depicted in detail.

Figure 6 – PP1 tacks: a) MT-1a; b) MT-1b.

Sample	Observations	Type of head and edge length (mm)	Length (mm)
MT-1a	Grey-greenish oxides cover the surface. No deformation in the body.	square $9 \pm 0,1$	$34 \pm 0,2$
MT-1b	Grey-greenish oxides cover the surface. Deformation seen in the body (curved)	square $9 \pm 0,3$	$33,4 \pm 0,5$

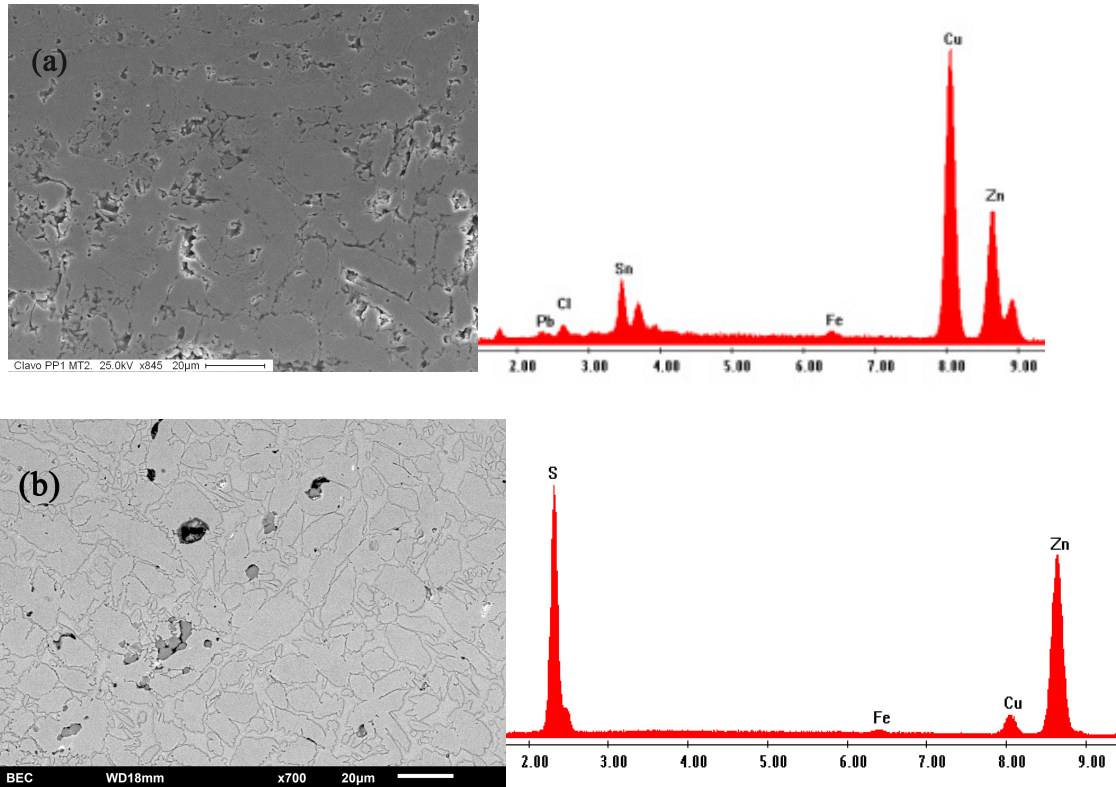
The average weight per cent composition of the tacks, analyzed via EDS in different areas, correspond to a biphasic brass $\alpha+\beta$ with 60,5% Cu, 39% Zn and Fe 0,7% (Fig. 7b). An alloy of similar composition was registered in two tack fragments from the same site. The presence of aligned nonmetallic particles, in which S and Zn are predominant (Fig. 7b) was detected at the head and shank of the MT-1a tack.

Figure 7 –SEM and EDS images of the MT-1a tack, corresponding to: a) The head-shank junction, a Sn-rich area; b) a string of sulphur precipitates in β phase.

In the previous sample, areas of a greater Sn concentration were observed at intergranular particles such as those close to the external surface of the head (Fig. 7a). The degradation process by dezincification reaches a depth of less than 0,5 mm. The change of the degraded area is clearly distinguished at a micrography of the shank's edge (Fig. 8a). In Fig. 8(b), taken at the tip, areas of material where no corrosion exist.

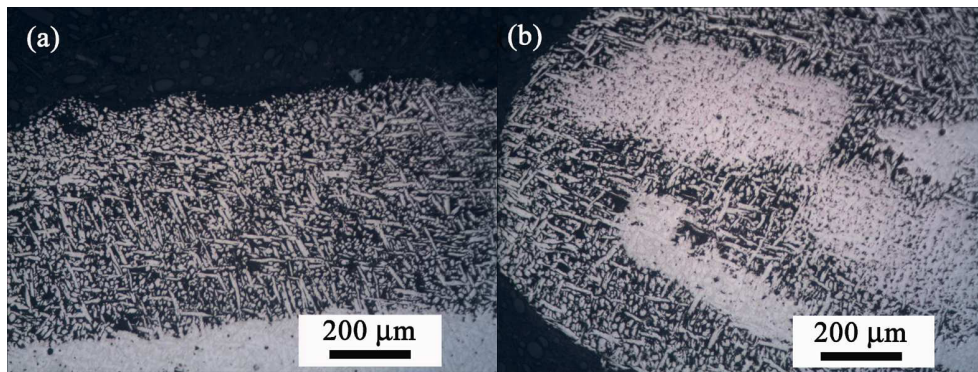
Figure 8 – MT-1a microstructure, as polished, in the following áreas: a) shank perimeter; b) tip.

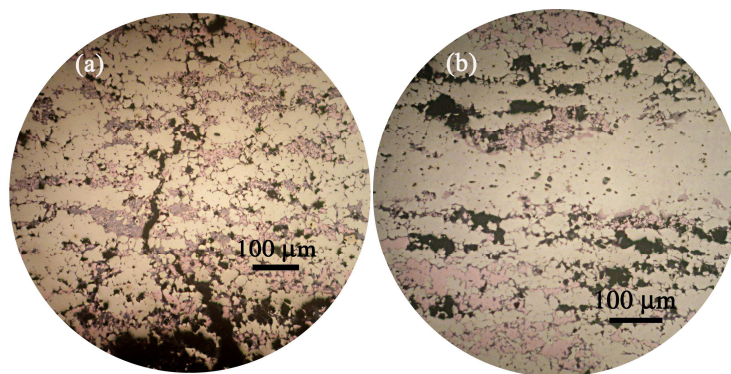
The MT-1b tack, on the other hand, presents a greater dezincification degree. The degradation process extended to a depth of 1 mm, both in the shank and the head.

Apart from dark oxides surrounding phase α , cracks crossing the sample and a high degree of porosity can be observed, also at the shank and the head.

Fig. 9 shows two micrographies of the unetched tack, at two areas of the shank: a) close to the edge; b) at the centre

Figure 9 – MT-1b tack photomicrography. As polished

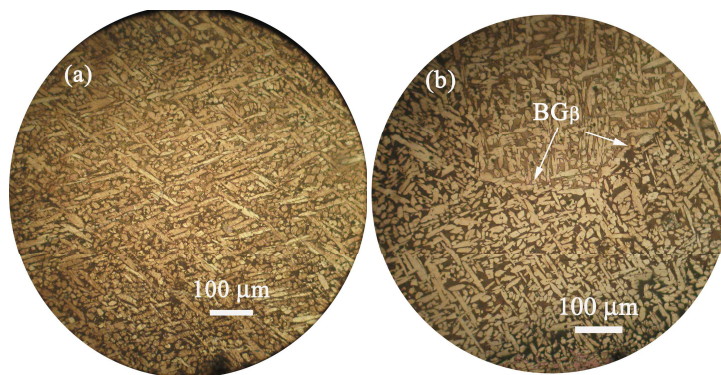
The microstructure observed at the centre of the MT-1a tack's shank, presents β matrix grains and acicular phase α , that grew from large grains of the former. These features are interpreted as a result of a long-lasting heating process at a temperature above 700°C - at which the material is in a state β -; then forming by deformation, giving enough time for recrystallization and grain growth to occur, but followed by fast cooling, which generated elongated grains of the new phase (Fig. 10b). Because of this, no traces of plastic deformation from phase β were left, and, as already noted, just a slight deformation of both phases in the head area can be appreciated.

Figure 10 – Microstructure of MT-1a tack, where two phases - α (light) and β (dark) can be appreciated: a) head; b) shank, BG β Grain boundary original β phase. Etchant: HCl FeCl_3 aqueous solution.

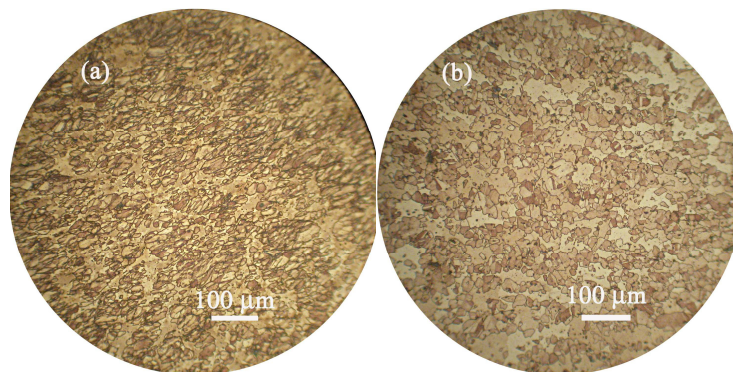
Furthermore, the microstructure of the MT-1b tack presents α phase grains of equiaxed morphology in a clearly oriented β matrix (longitudinal at the shank and transverse at the head). It only exhibits a slight deformation of the α grains at the upper zone of the head, appreciated in the curvature of annealing twins (Fig. 11a). Here, the forming lines converge towards the centre of the piece. In Fig. 12, the aligned microstructure resulting from hot forming is indicated with dotted lines.

Figure 11 – Microstructure of the MT-1b tack: a) head; b) shank. Etchant: $\text{NH}_4\text{OH}:\text{H}_2\text{O}:\text{H}_2\text{O}_2$

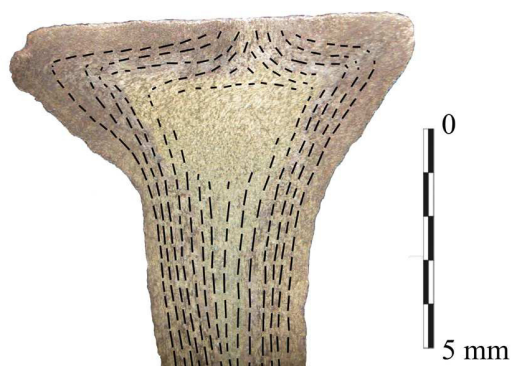
Figure 12 – Longitudinal section of MT-1b tack. The orientation of the microstructure resulting from the forming process is highlighted.

According to what was observed, MT-1b tack presents a microstructure consistent with a hot forming process. Considering the orientation and morphology of the shank and head grains, it can be assumed that the manufacturing
